Figure 1. Location of the Los Alamos National Laboratory and Study Area (Source: LANL 1998a).

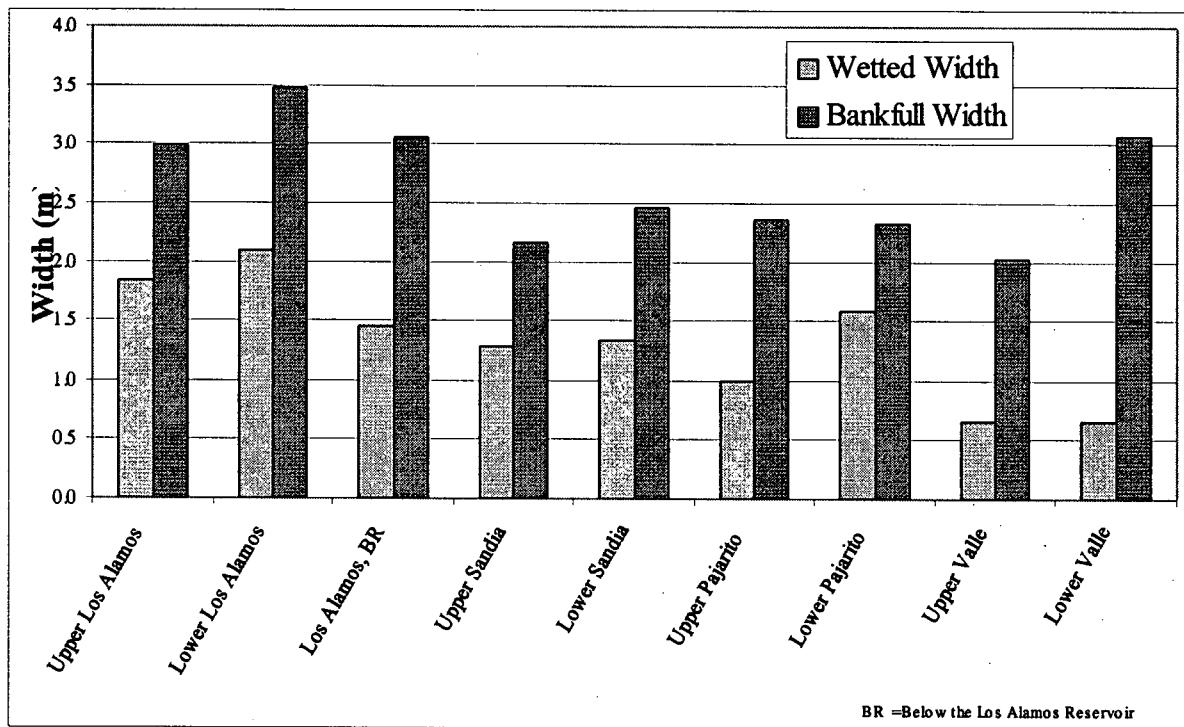
Figure 69. Average Wetted Width and Average Bankfull Width for Each Stream Reach.

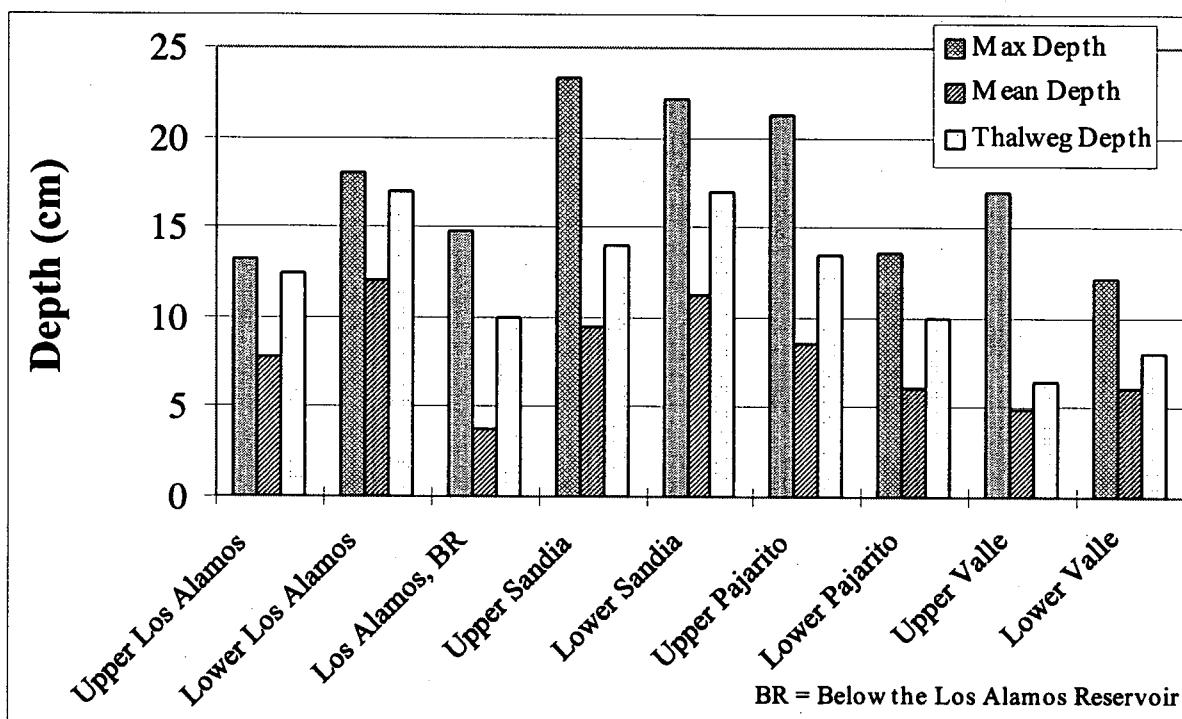
Figure 70. Mean, Maximum, and Thalweg Depth of Each Stream Reach Measured in 1997.

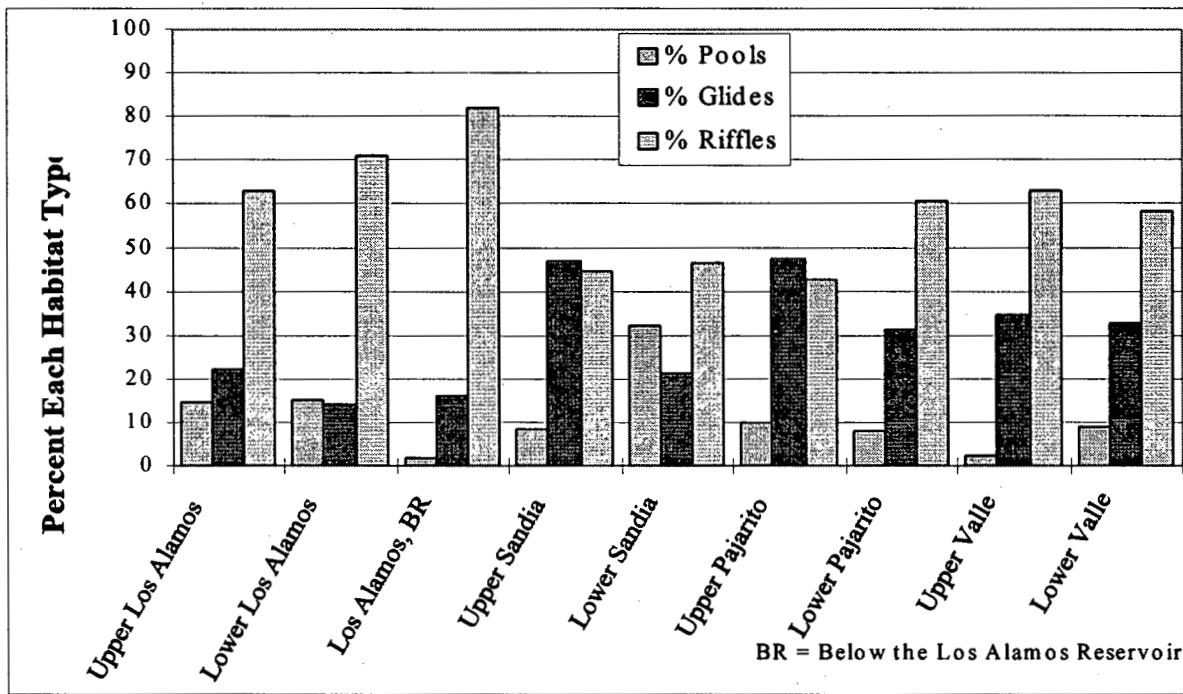
Figure 71. Percentage of Pools, Glides, and Riffles (expressed as a percentage of total wetted stream area) for Each Stream Reach Measured in 1997.

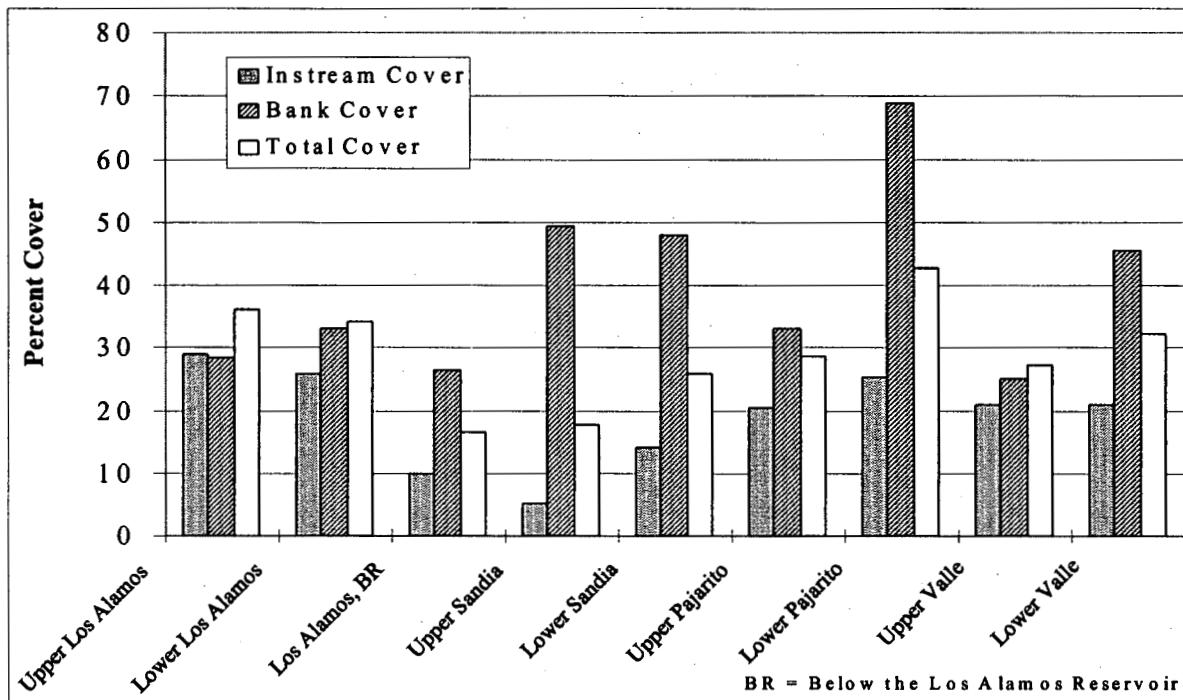
Figure 72. Percentage of Instream Cover, Bank Cover, and Total Cover (expressed as a percentage of the total wetted stream area) for Each Stream Reach in 1997.

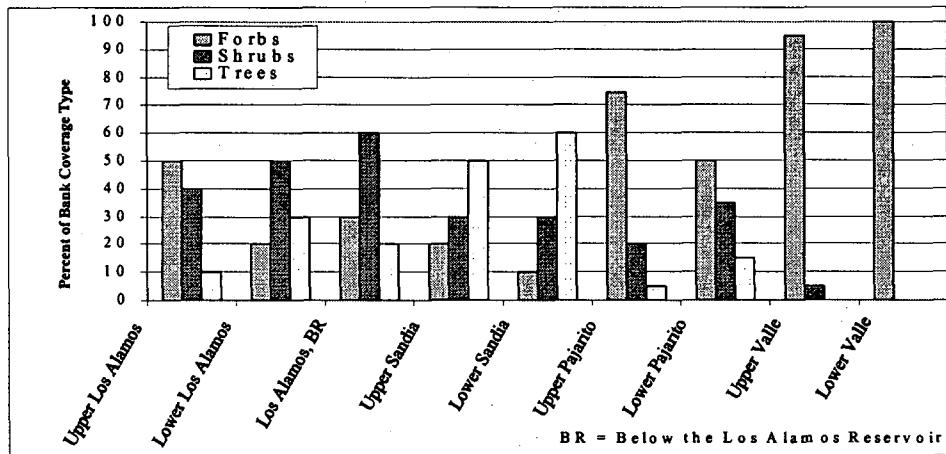
Figure 73. Percentage of Bank Cover Types (Forbs, Shrubs, or Trees) for Each Stream Reach Measured in 1997.

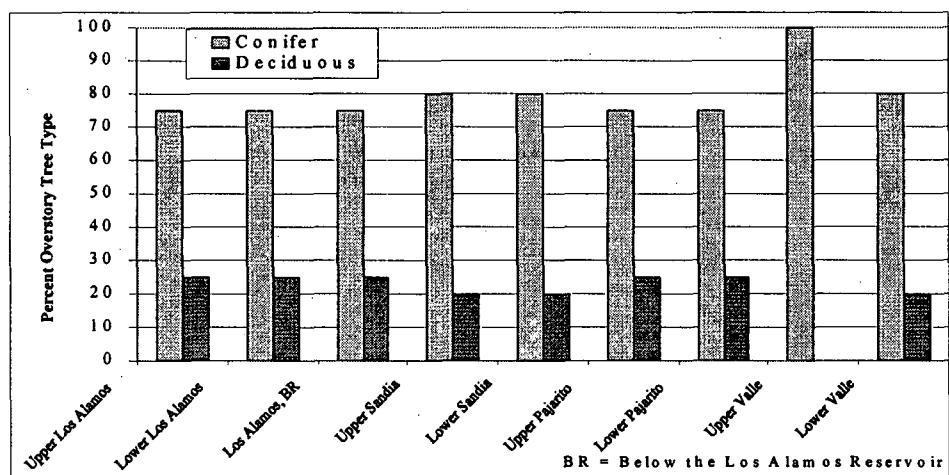
Figure 74. Percentage of Overstory Cover (expressed as a percentage of total riparian area) in the Form of Coniferous and Deciduous Trees for Each Stream Reach in 1997.

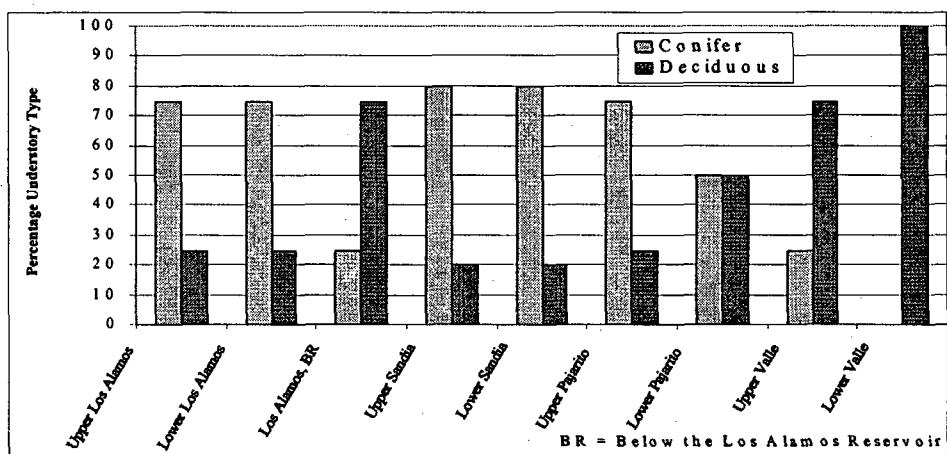
Figure 75. Percentage of Understory Cover (expressed as a percentage of total riparian area) in the Form of Coniferous and Deciduous Trees for Each Stream Reach in 1997.

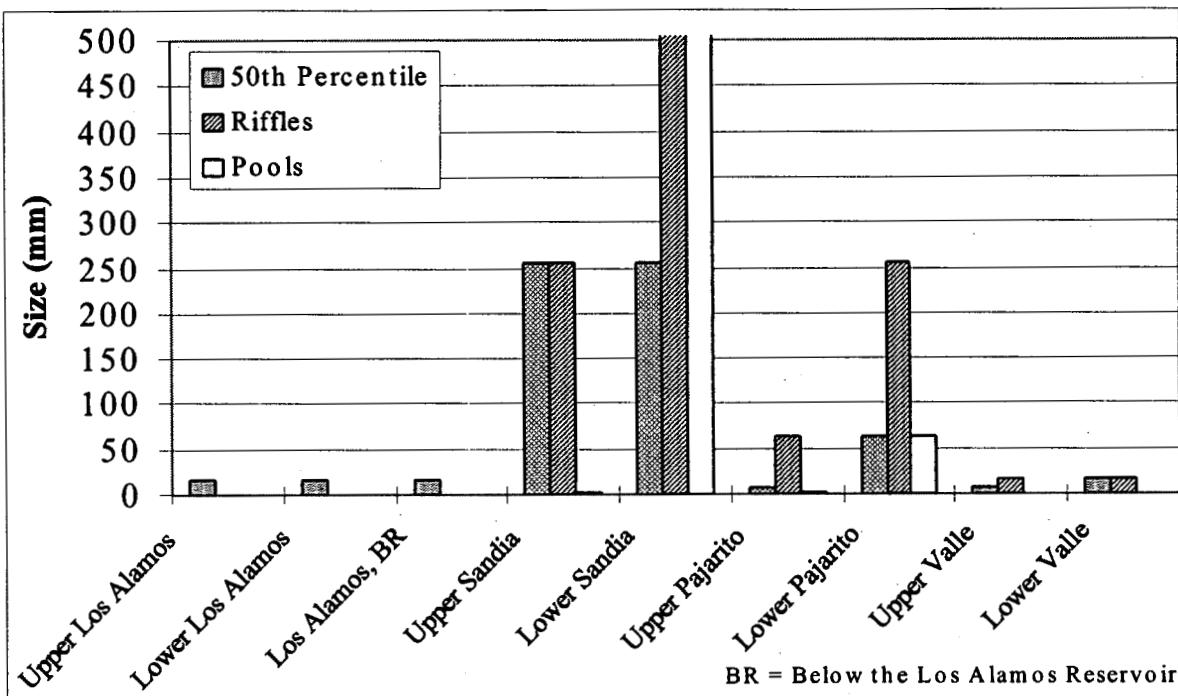
Figure 76. Stream Substrate Size Characteristics in Riffles, in Pools, and the 50th Percentile Distribution of Substrate Sizes for each Stream Reach Measured in 1997.

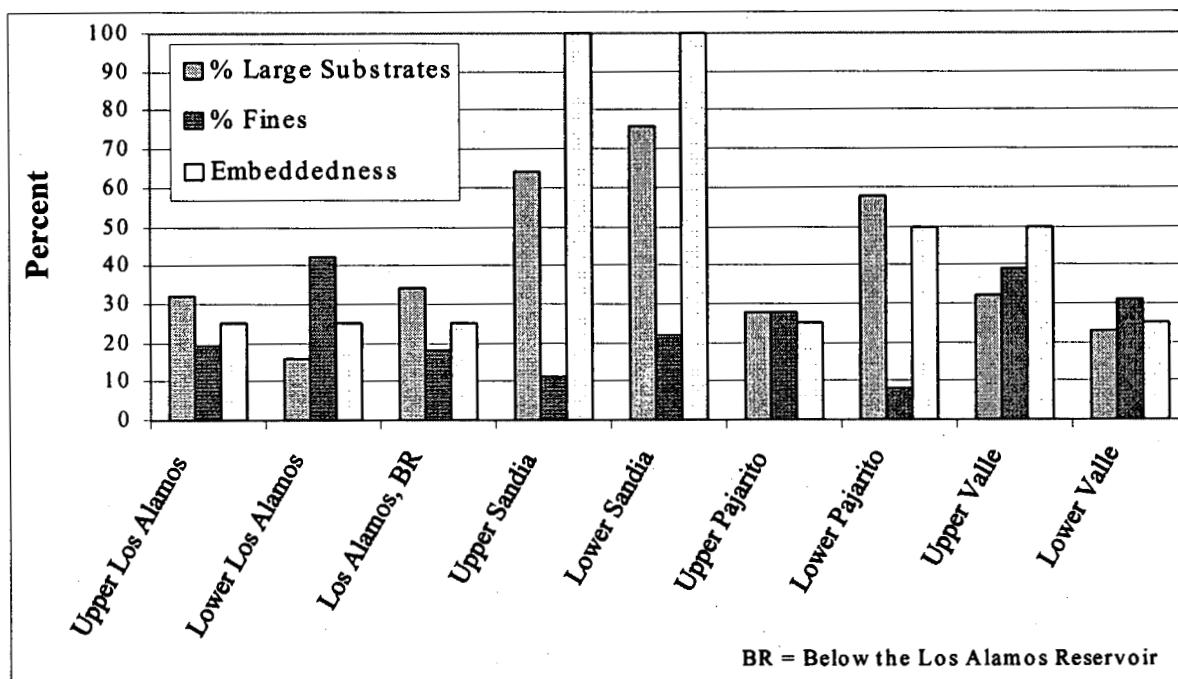
Figure 77. Stream Substrate Characteristics Expressed as Large and Fine Substrates as well as Percent Embeddedness of Large Substrates by Fines for Each Stream Reach.

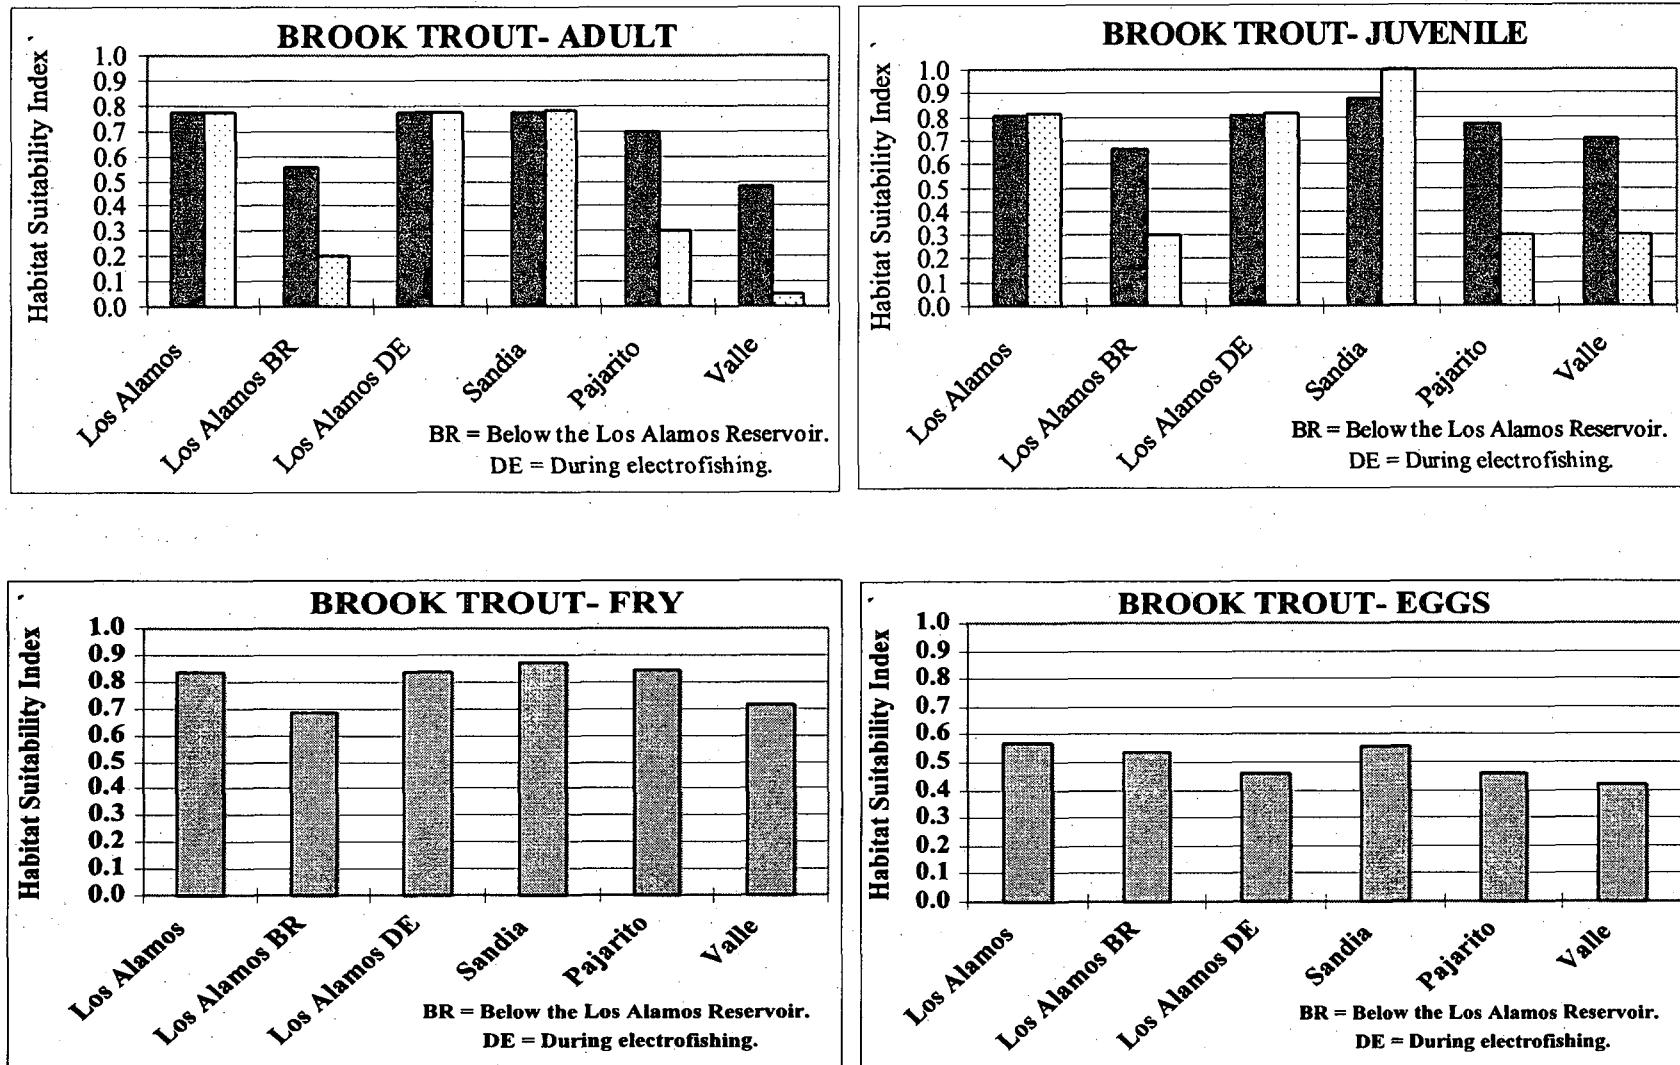
Figure 78. Mean Habitat Suitability Index (HSI) Scores for Each Stream Segment for Adult, Juvenile, Fry, and Eggs of Brook Trout. For Illustrative Purposes, Adult and Juvenile Graphs Include Two Sets of Bars. Closed Bars Reflect the HSI Scores Before Water Depth and/or Pool Quality were Considered. Open Bars are the Final HSI Scores.

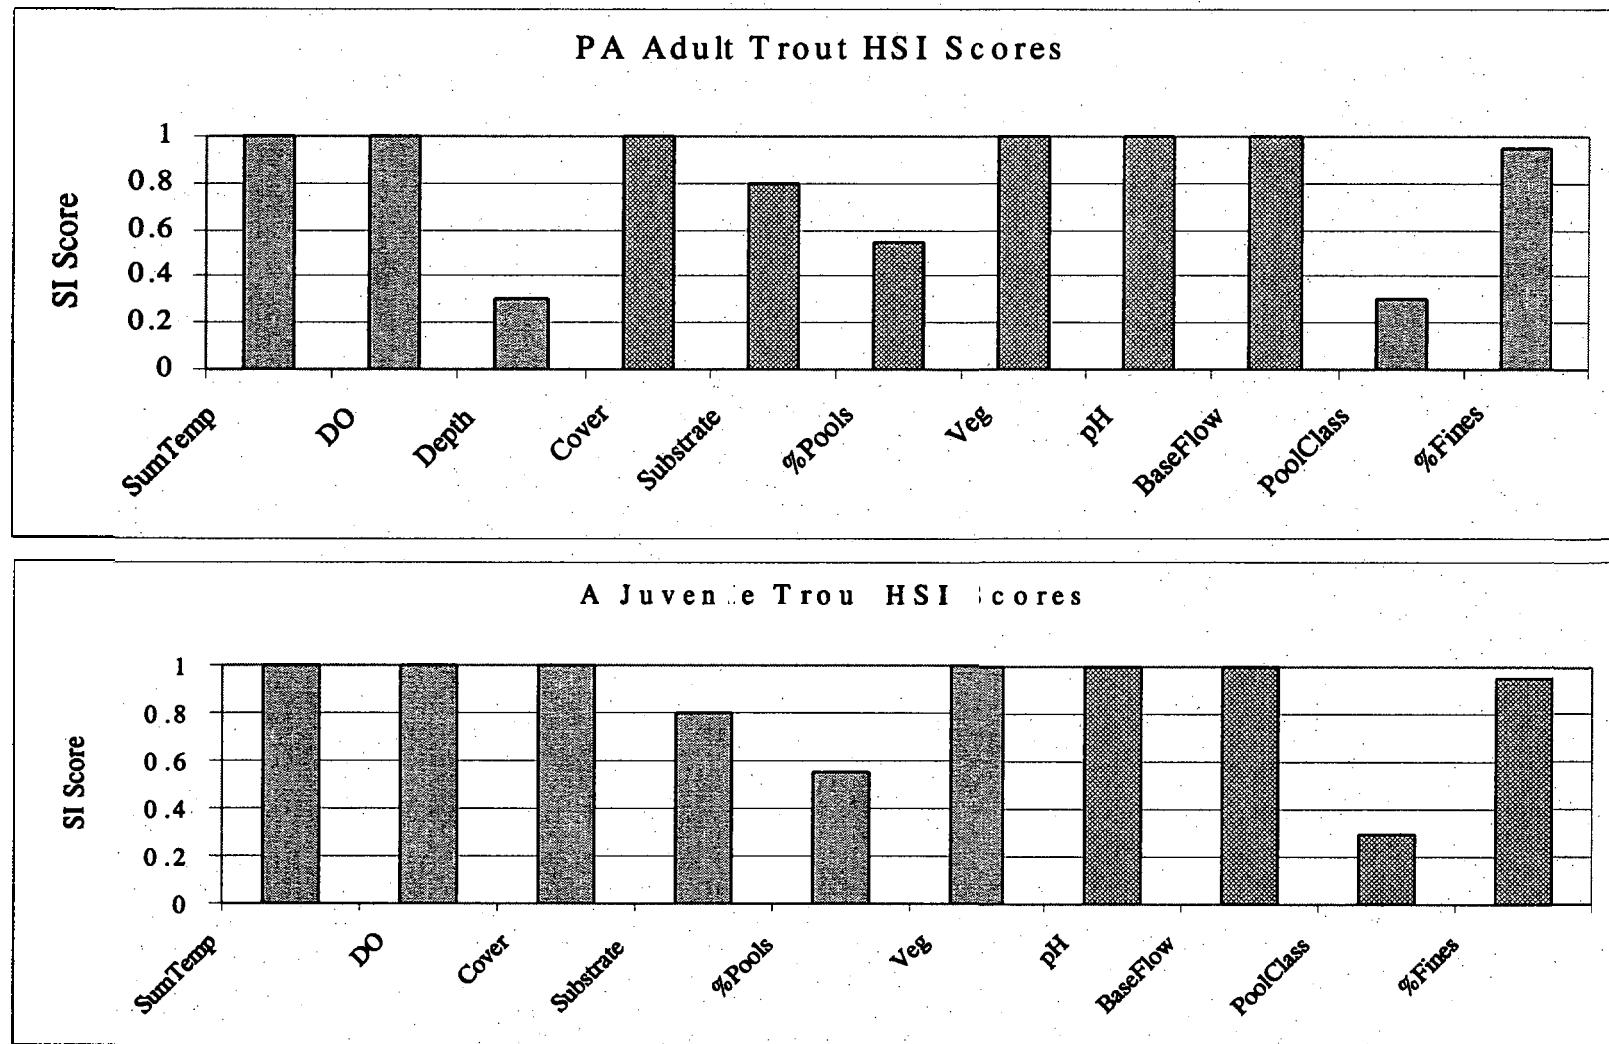
Figure 79. Mean Individual Habitat Suitability Scores (SI) for the Brook Trout HSI Model, Measured in Pajarito Canyon (PA) in 1997.

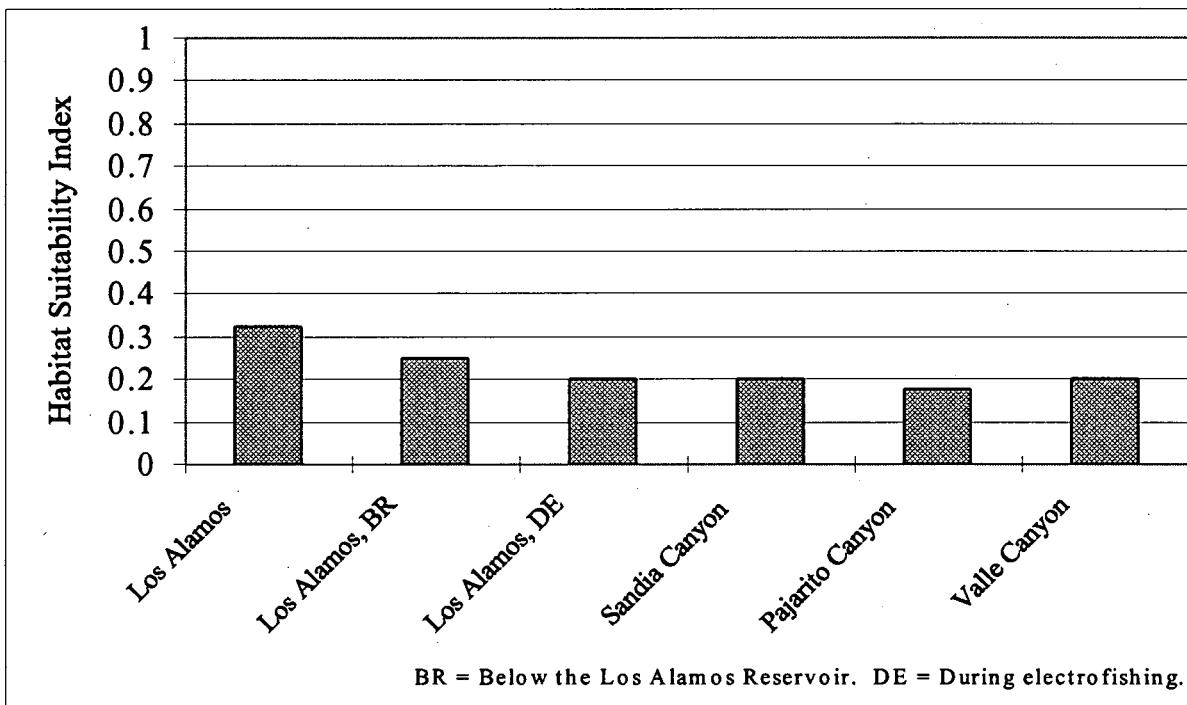
Figure 80. Overall Longnose Dace Habitat Suitability Index for Canyon Streams in 1997.

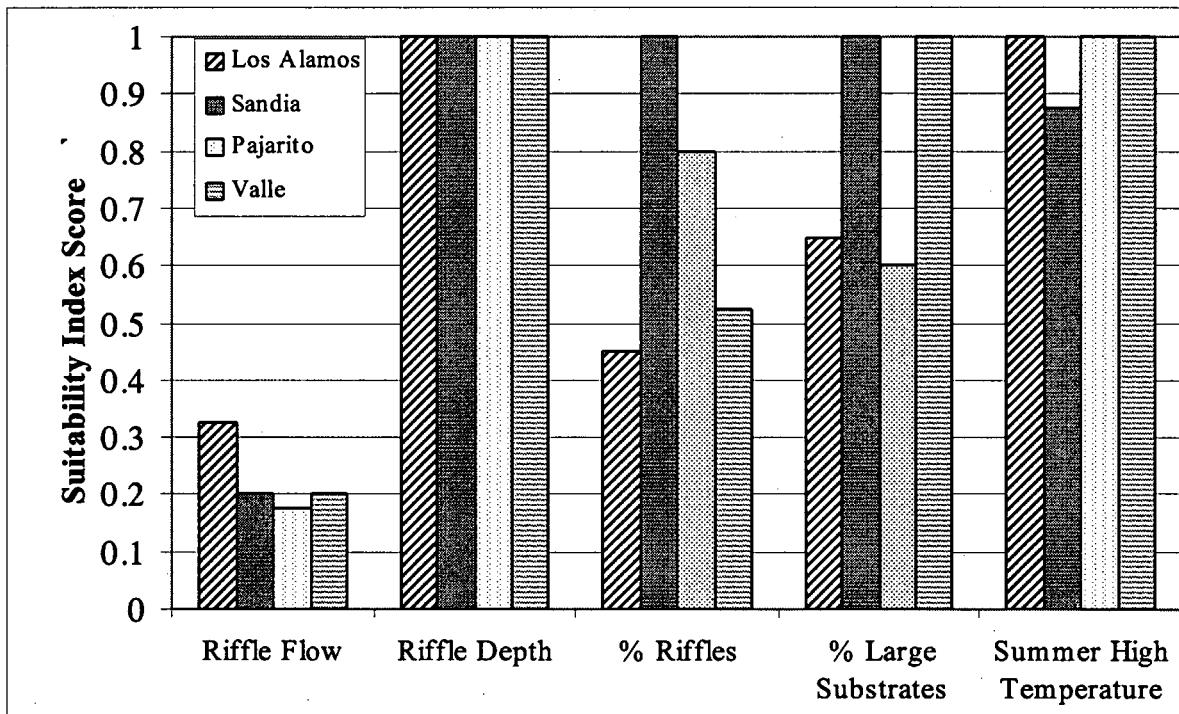
Figure 81. Mean Individual Habitat Parameter Scores for the Longnose Dace Suitability Index Model for Each Stream Reach Measured in 1997.

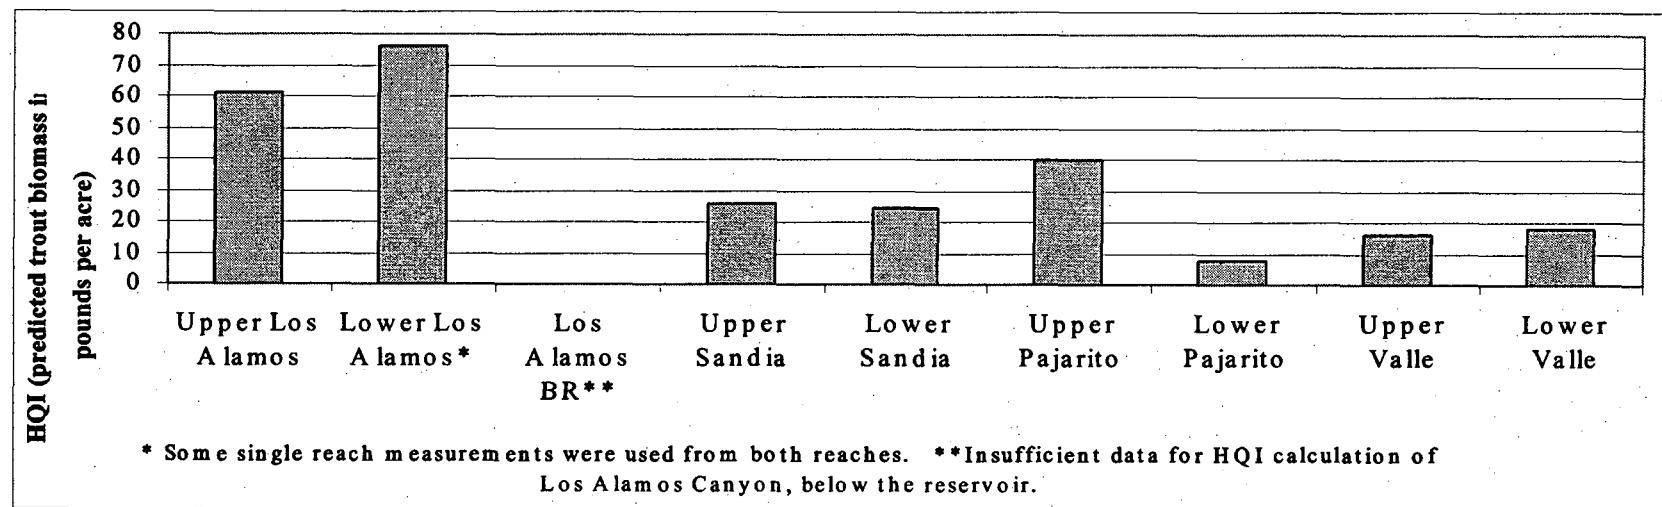
Figure 82. Predicted Trout Biomass (*i.e.*, Standing Crop Density) using the Habitat Quality Index (HQI) for Each Stream Reach.

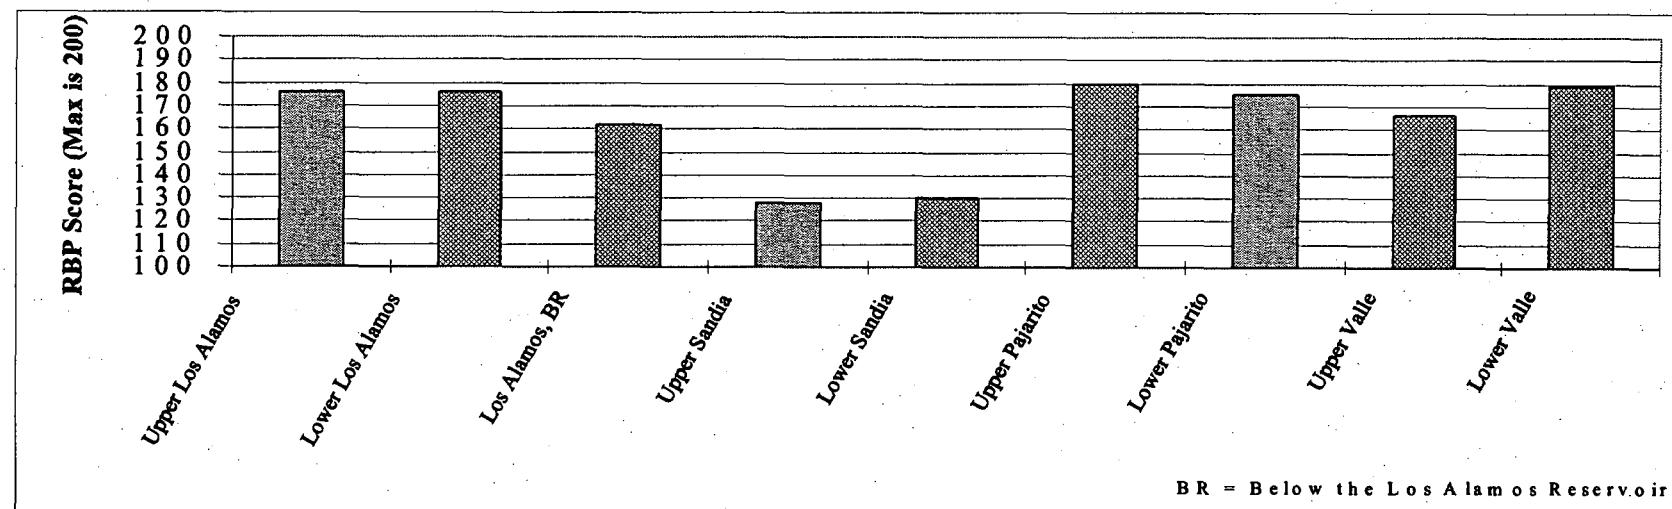
Figure 83. Rapid Bioassessment Protocol (RBP) Scores of Invertebrate Habitat Suitability for Each Stream Reach in 1997.

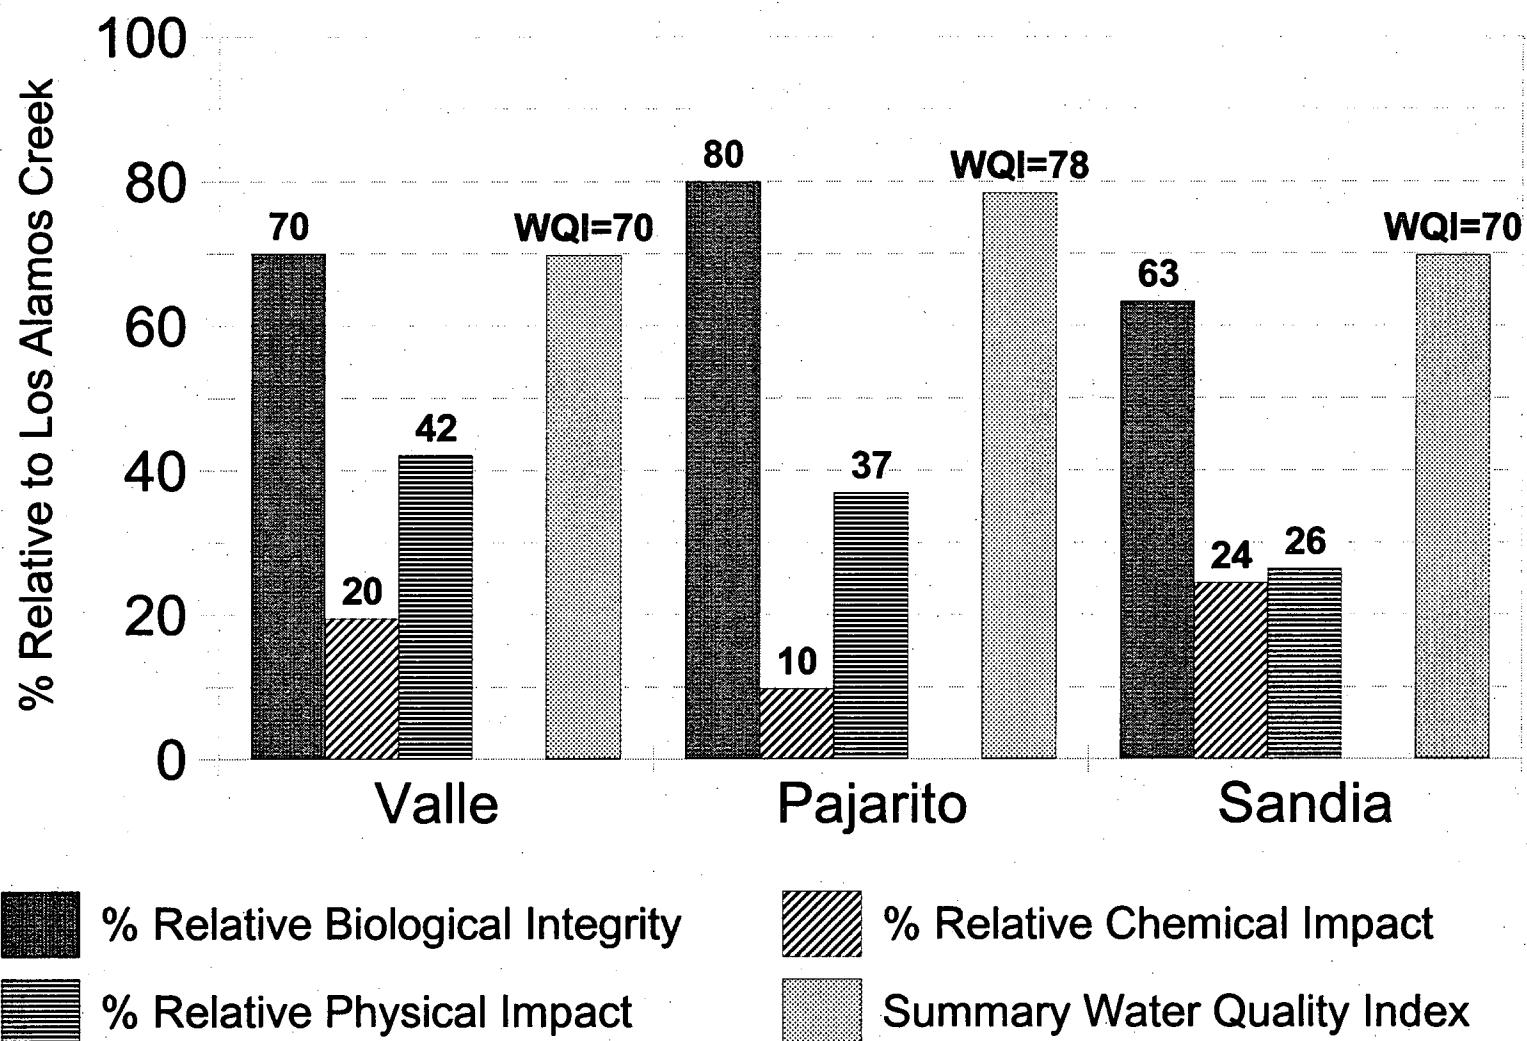
Figure 84. Relative Biological Integrity, the Percent Chemical and Physical Impact, and the Water Quality Index (WQI) for Valle, Pajarito, and Sandia Canyon Stream Segments Compared to Los Alamos Canyon Stream Segment as a Reference Site.
